**North Slope of Alaska ARM Facilities
Monthly Status Update
Sandia National Labs**

April 2017

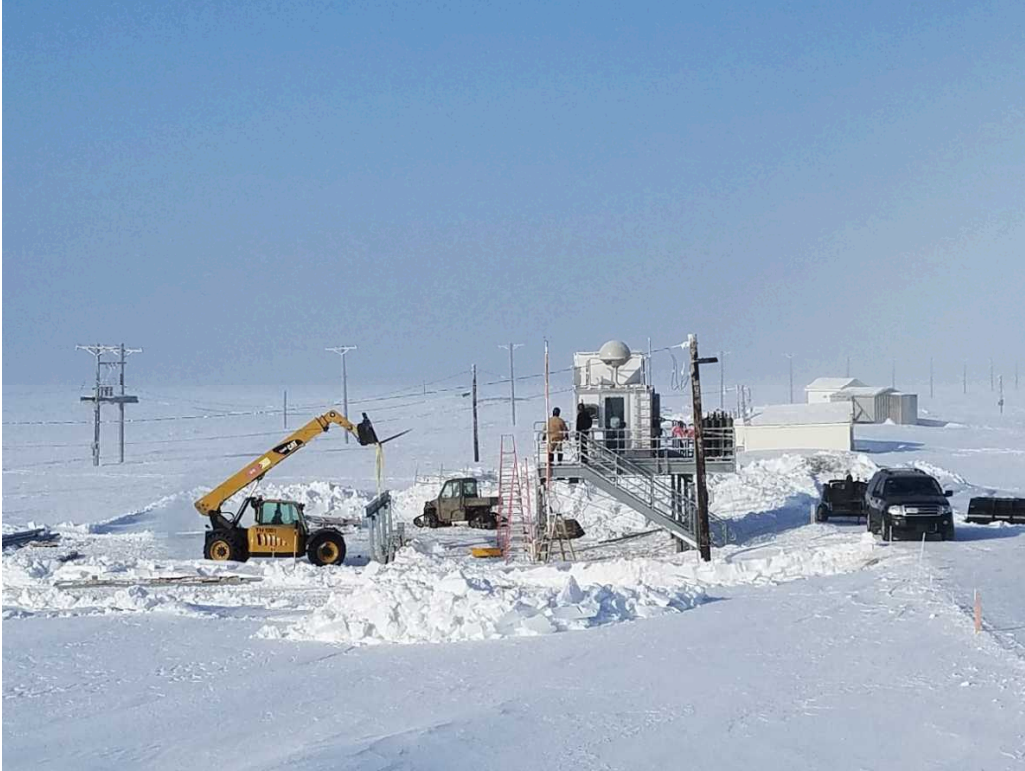
Before

Balloon auto launcher deck extension completed April 17-28.
